United States Coast Guard, First District
Lighthouse Protection Studies, New England

Sankaty Head Light Station Nantucket, Massachusetts

US Army Corps
of Engineers
New England Division

SANKATY HEAD LIGHT STATION, NANTUCKET, MA
EROSION STUDY

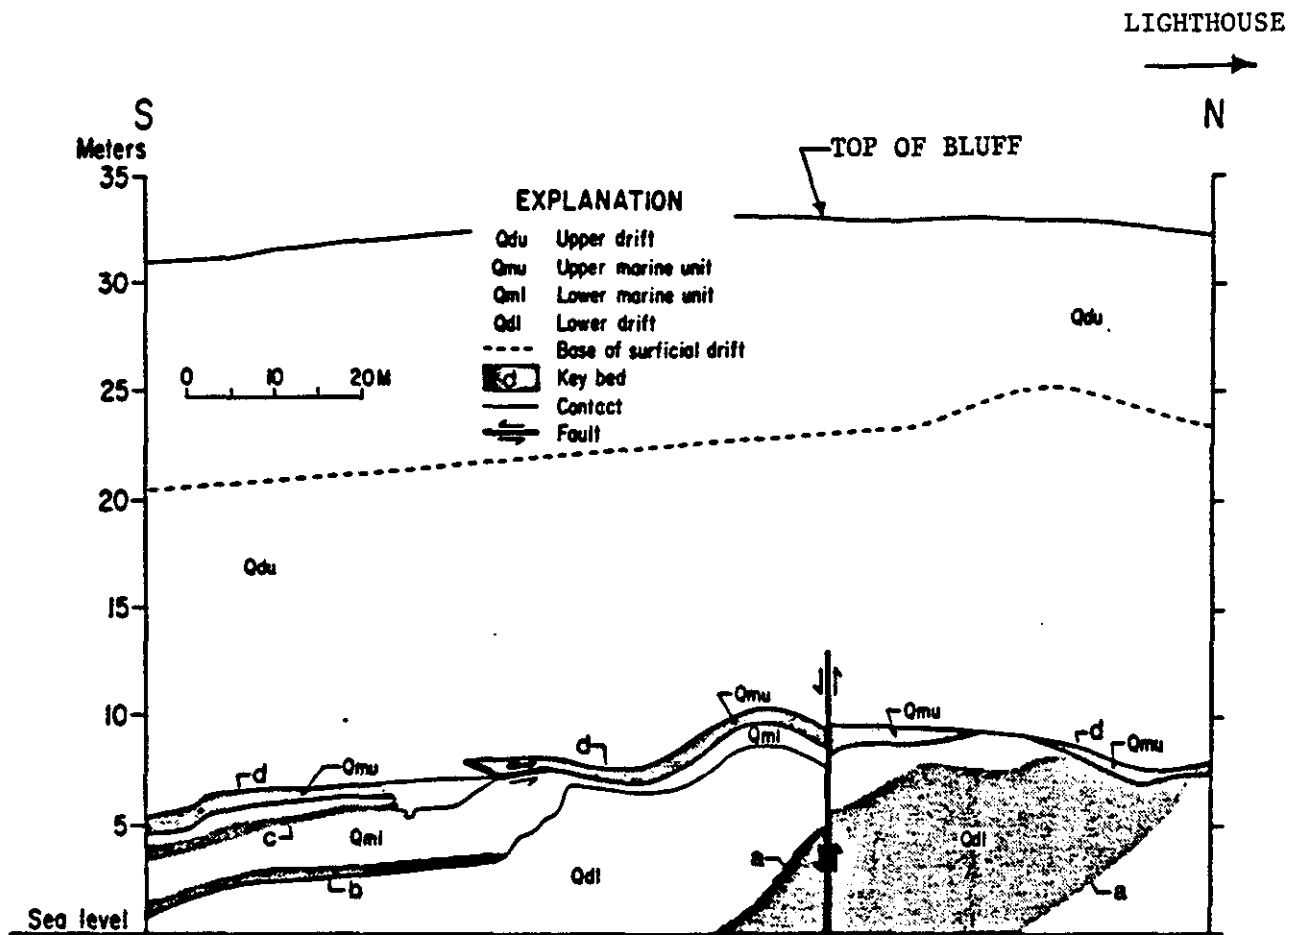
Sankaty bluff is entirely wave cut in origin. Waves undercut the bluff especially in storm conditions. The resultant over steepening causes slumping and bluff failure by mass wasting. Because of the abundant clay in the sediments composing the bluffs, the slumping and failure is periodic and incremental and occasionally catastrophic in nature.

Section showing the distribution of the upper Pleistocene deposits exposed at Sankaty Head, Nantucket. Key beds include: (a) till in lower drift, (b) basal marine gravel, (c) lower part of Sankaty Sand, (d) upper part of Sankaty Sand. North side of section, 286 m south of Sankaty Head lighthouse.

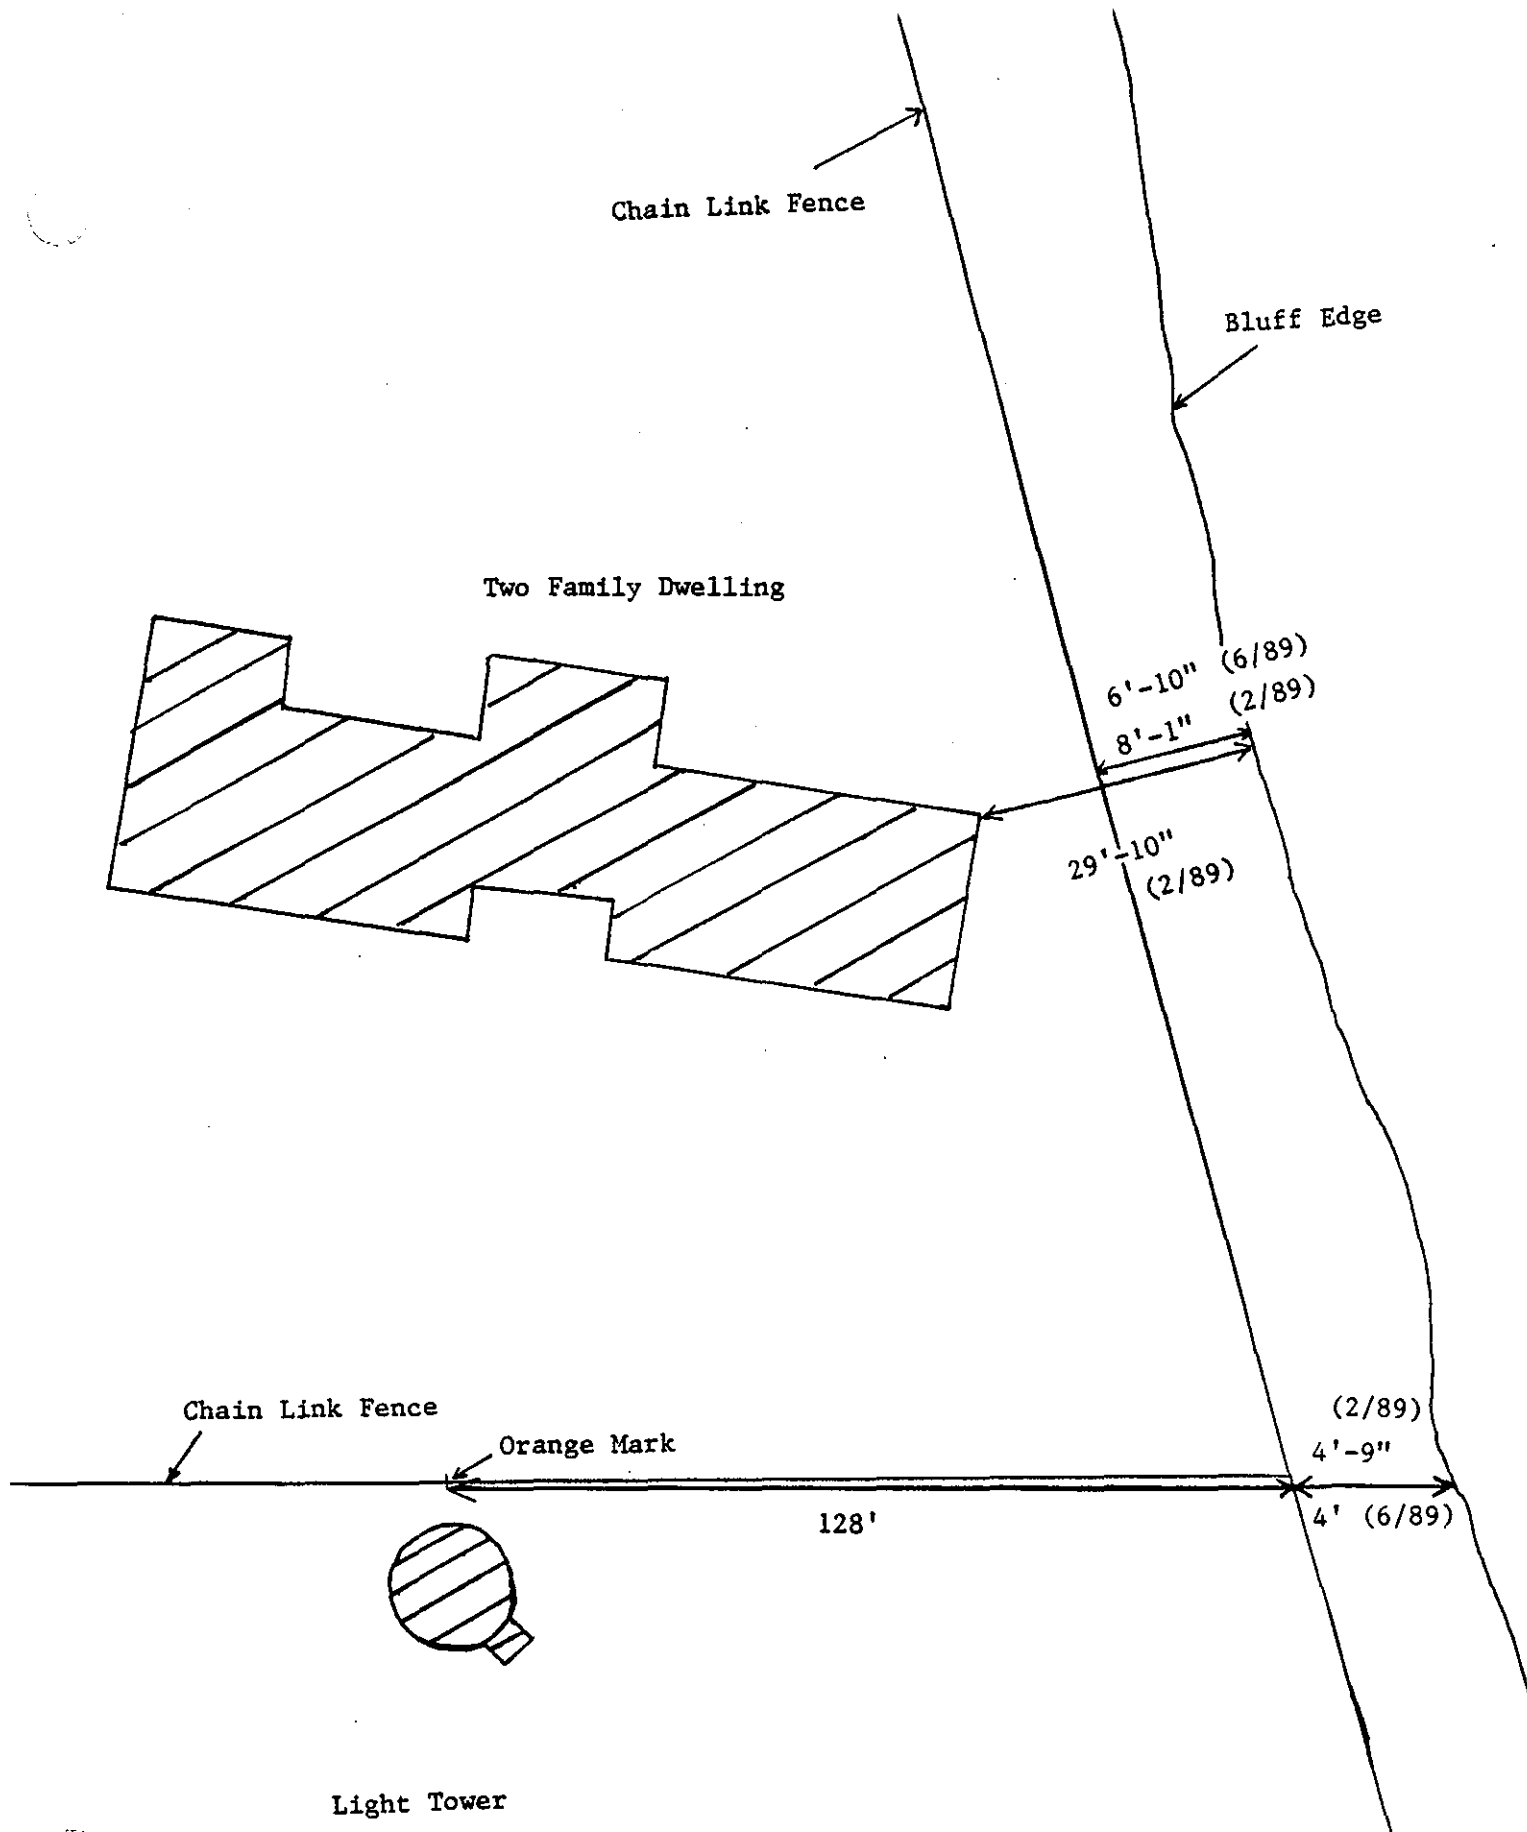
FIGURE 6
MEASUREMENTS AT LIGHTHOUSE PROPERTY - FEB. & JUNE, 1989
NOT TO SCALE

Personnel from the Corps of Engineers measured distances from the lighthouse and from the residences to the edge of the bluff in February and June of 1989. These measurements are detailed on Figure 6 on page 18. In February, the lighthouse was 132.75 feet from the edge of the bluff. This was measured along the chain link fence adjacent to the lighthouse, from an orange mark on the fence to the edge of the bluff. Also, at this time, the residences to the north were just under 30 feet from the edge of the bluff as measured from its closest corner to the edge. A subsequent site visit in June 1989 revealed that the distance from the fence line to the edge had decreased nine inches at the lighthouse and one foot-three inches near the residences. (See Figure 6.) There are portions of the bluff which are undercut by erosion with vegetation and roots overhanging the edge, and areas where the ground surface is showing signs of sloughing. (See Photo 4) The top portion of the bluff drops about 5 feet vertically and also shows signs of recent erosion and movement of slope material. The edge of the bluff was also soft, loose, and easily eroded in June of 1989. (See Photo 5.) Also, sloughed material and vegetation from the top of the bluff can be seen at the lower elevations on the slope indicating downward movement of bluff material.

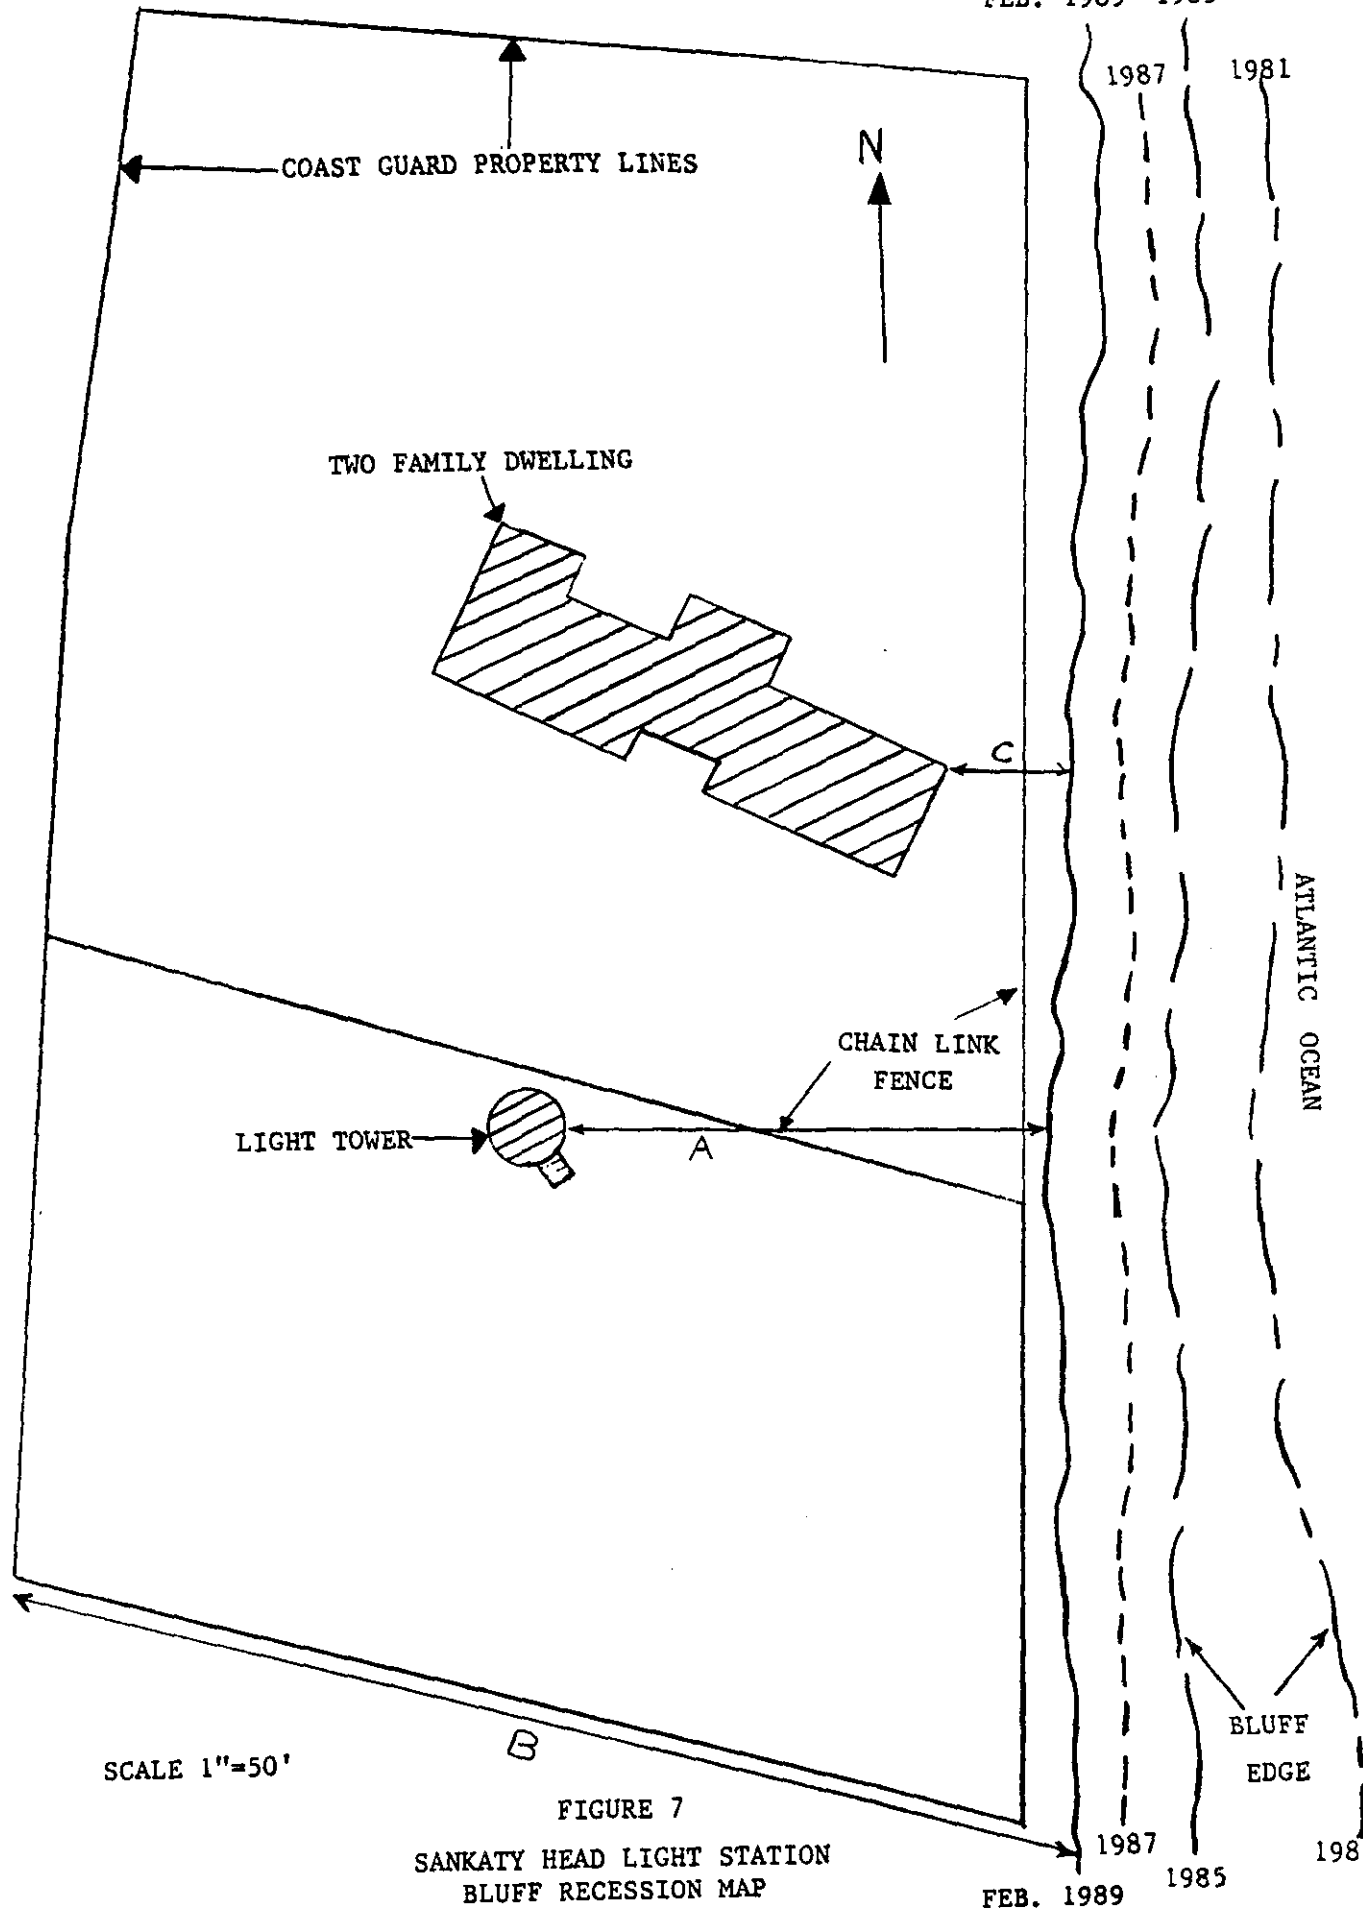
FIGURE 7
SANKATY HEAD LIGHT STATION
BLUFF RECESSION MAP

In summary, the top of the bluff in front of the lighthouse is eroding at an average rate of 8.0 feet per year over the last two years, 1987-1989. Photos 12, 13 & 14 show the dramatic recession of the bluff edge between September of 1985, and February and June of 1989. This situation will most likely persist until offshore bathymetry conditions change which may offer some form of natural protection to the base of the bluff, and the slope of the bluff stabilizes.

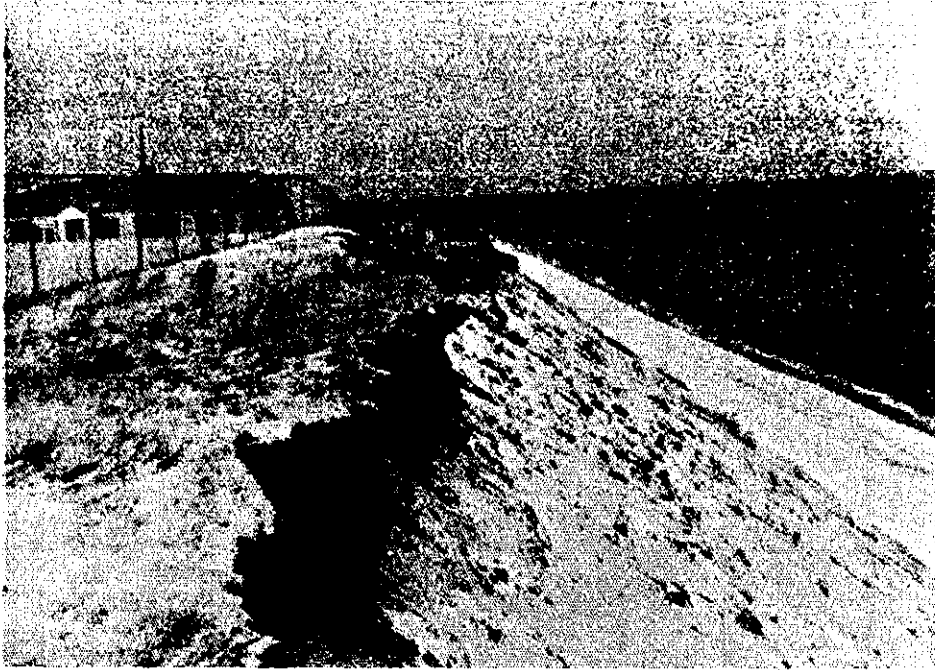
Recent observations made by Corps personnel in early 1989 suggest the bluff is retreating at a maximum rate of 8 feet per year. The most critical area of the lighthouse property is clearly the portion of bluff directly in front of the residences. (See Photos 11, 12, 13 & 14.)

PHOTO 13 - TOP EDGE OF BLUFF, FEBRUARY 1989

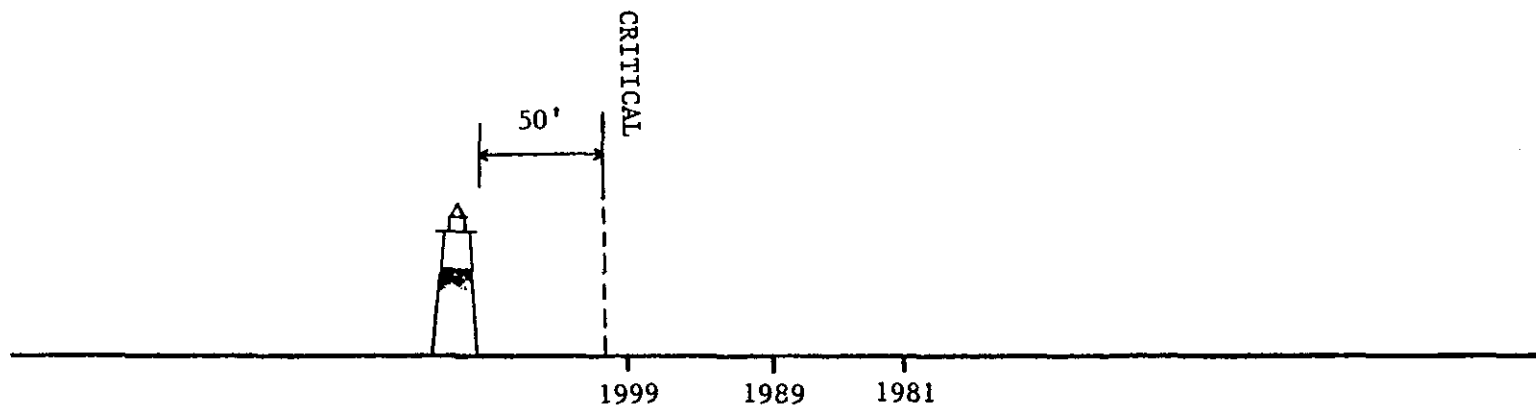
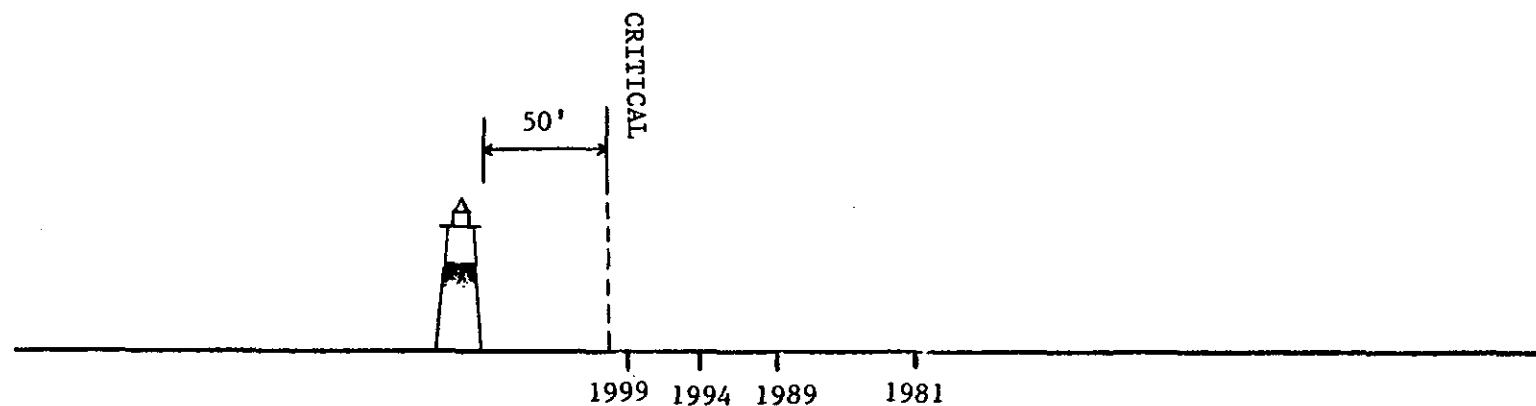
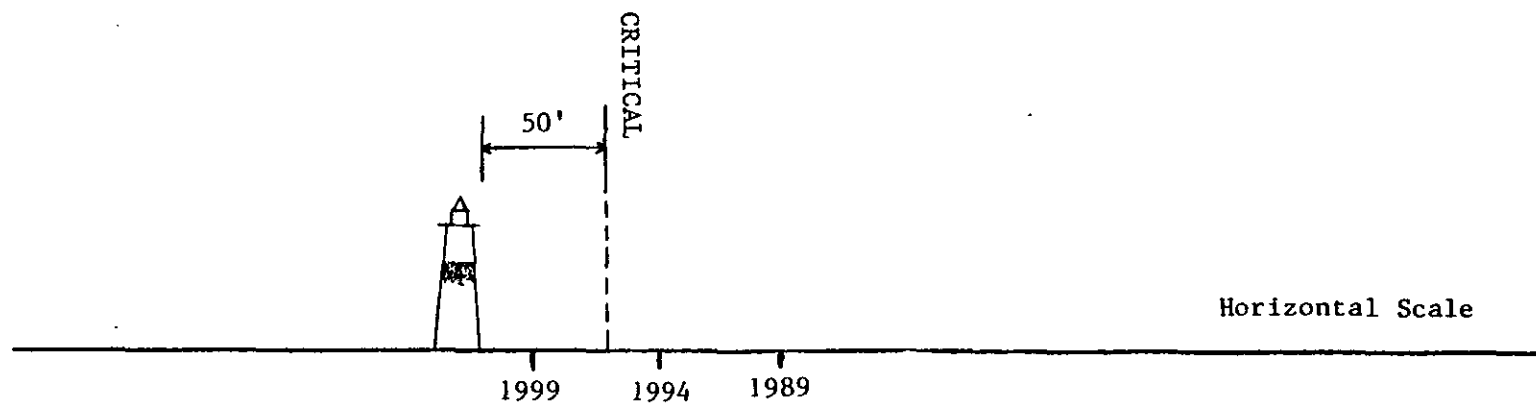
The "best possible case" is an estimate of how much the bluff will recede after erosion is halted at the base of the bluff due to wave attack. If erosion were stopped today, the top edge of the bluff would still recede until the slope attained its natural angle of repose, although the rate of recession will decrease until the slope stabilizes. The angle of repose is the natural angle the slope will take if left relatively undisturbed by erosion at the base of the bluff. This angle is approximately 29 degrees to the horizontal for the bluffs at Sankaty Head. The angle the bluff makes with the horizontal is presently 35-36 degrees. Therefore, the bluff will retreat another 61 feet before stabilizing, leaving only 63 feet between the lighthouse and the edge. This would probably occur within a decade after stabilizing the base of the bluff against erosion. Figure 10 shows the approximate edge of the bluff for this scenario in 10 years, assuming bluff erosion is stopped in 1989. It can be seen that even this scenario poses a significant threat to the lighthouse structure because it still leaves the lighthouse perilously close to the edge.

The "most likely case" uses the rate of bluff recession measured in front of the lighthouse of 8 feet per year over the last two years. This would give the lighthouse less than 16 years before it would go over the edge. The "Historical Analysis" section suggests that the present bluff recession began in 1981 and the average rate of bluff recession since 1981 is 6.5 feet per year. Therefore, in five years, the bluff edge will be about 93 feet away

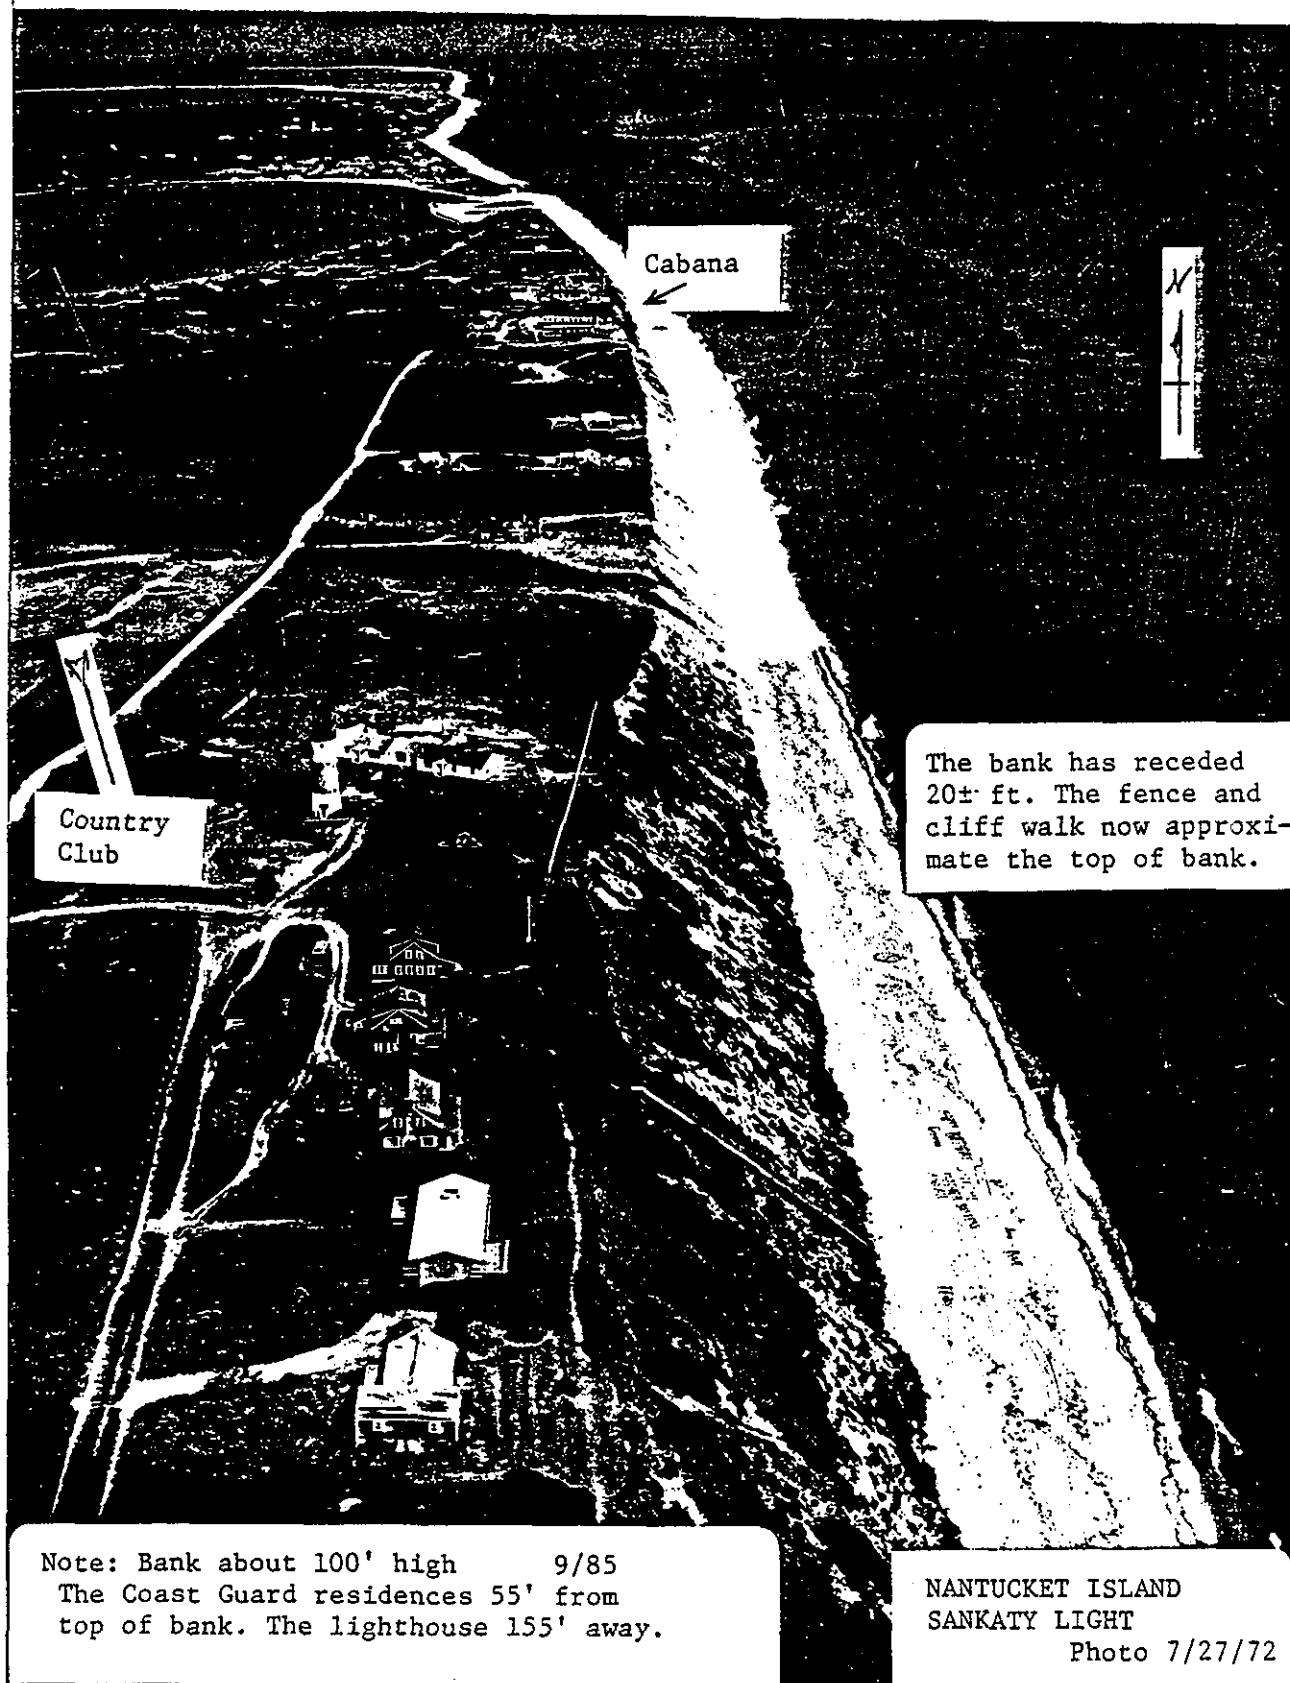
NANTUCKET ISLAND
SANKATY LIGHT

Note: Bank about 100' high 9/85
The Coast Guard residences 55' from
top of bank. The lighthouse 155' away.

The bank has receded
20± ft. The fence and
cliff walk now approxi-
mate the top of bank.

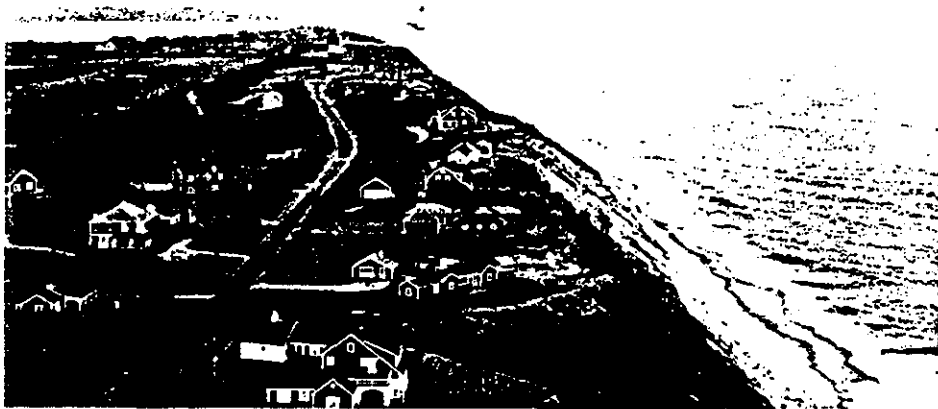
Sankaty Light 9/19/85
Looking from the South

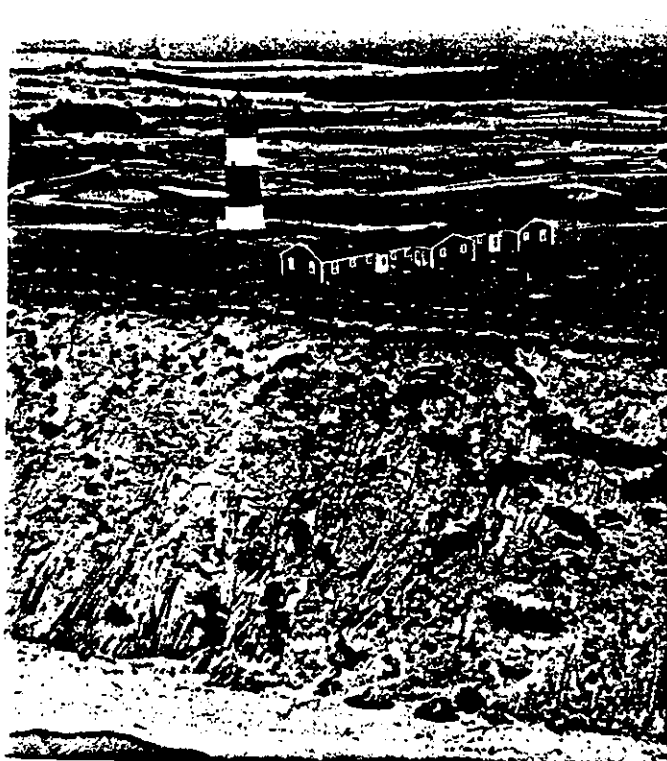
Sankaty Light 9/19/85
Looking from the East

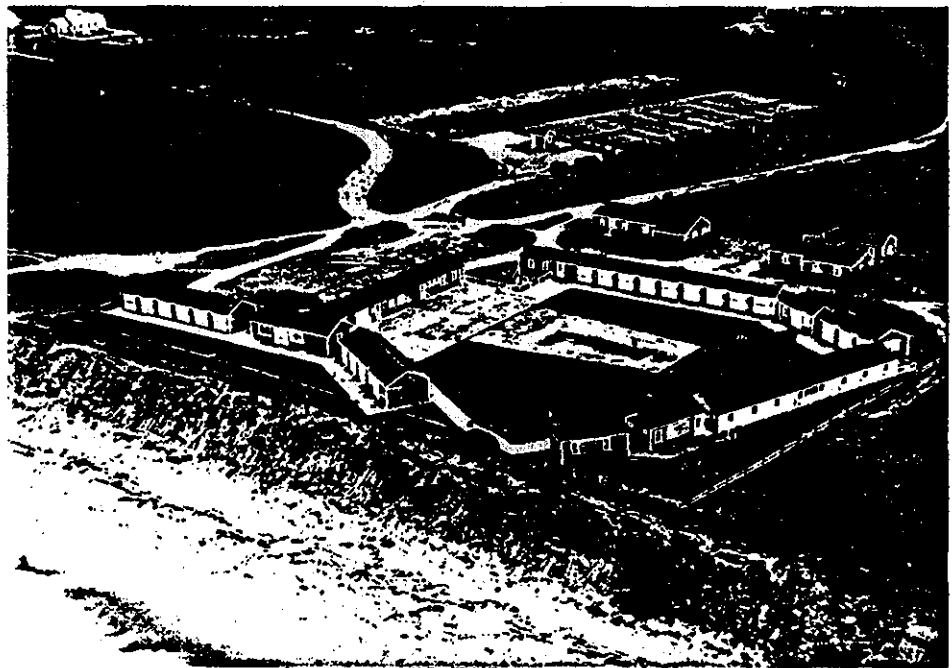
Sankaty Light 9/19/85
Cabanas located about 0.6
miles south of Sankaty Light

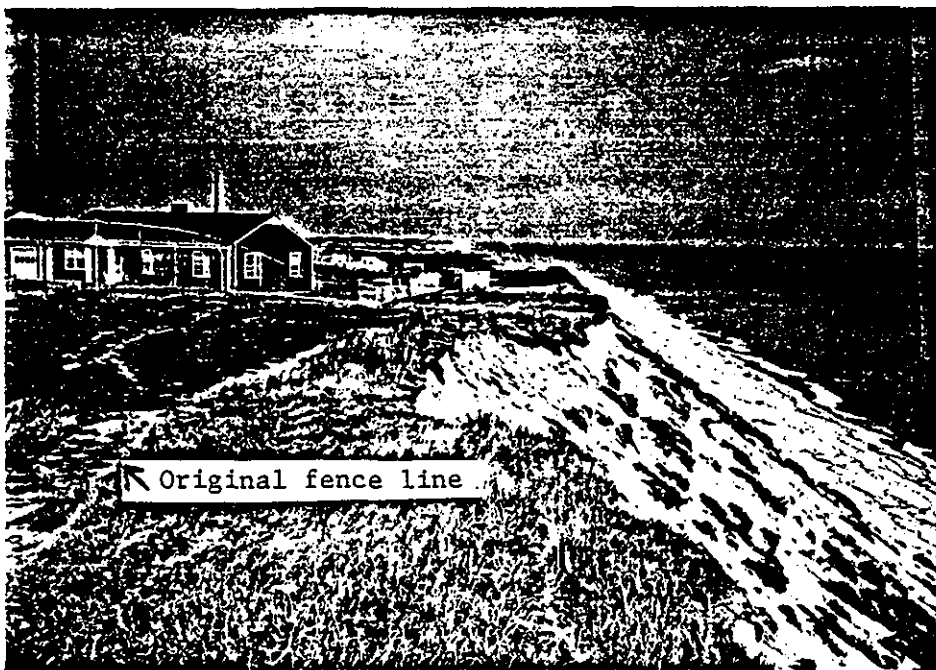
Sankaty Light 9/19/85

U.S. Coast Guard
Station

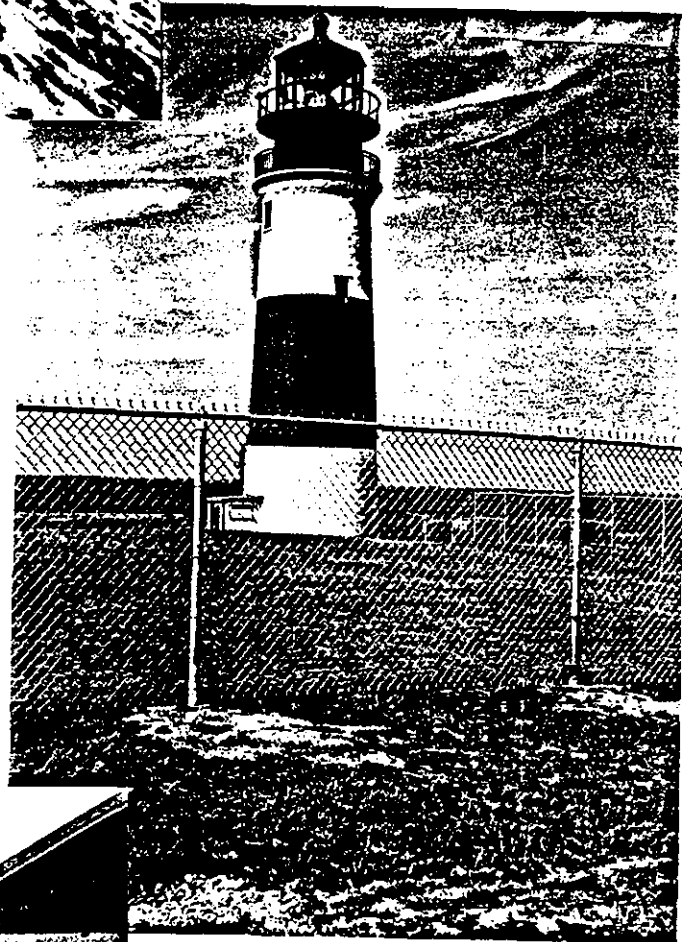
Sankaty Light 9/19/85

Relocated Fence

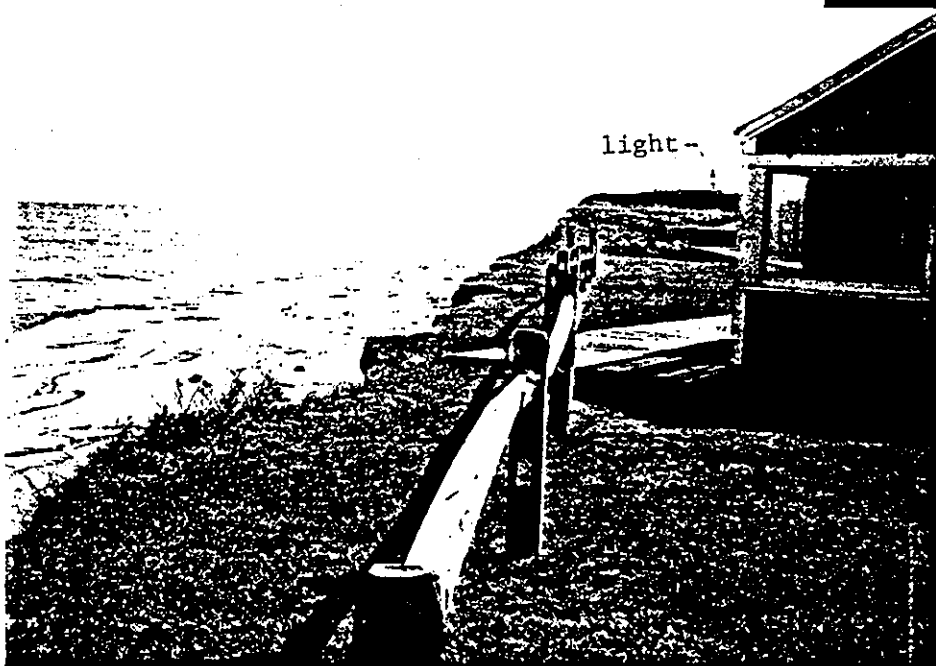
Sankaty Light

Cabanas located about
0.6 miles South of the light.

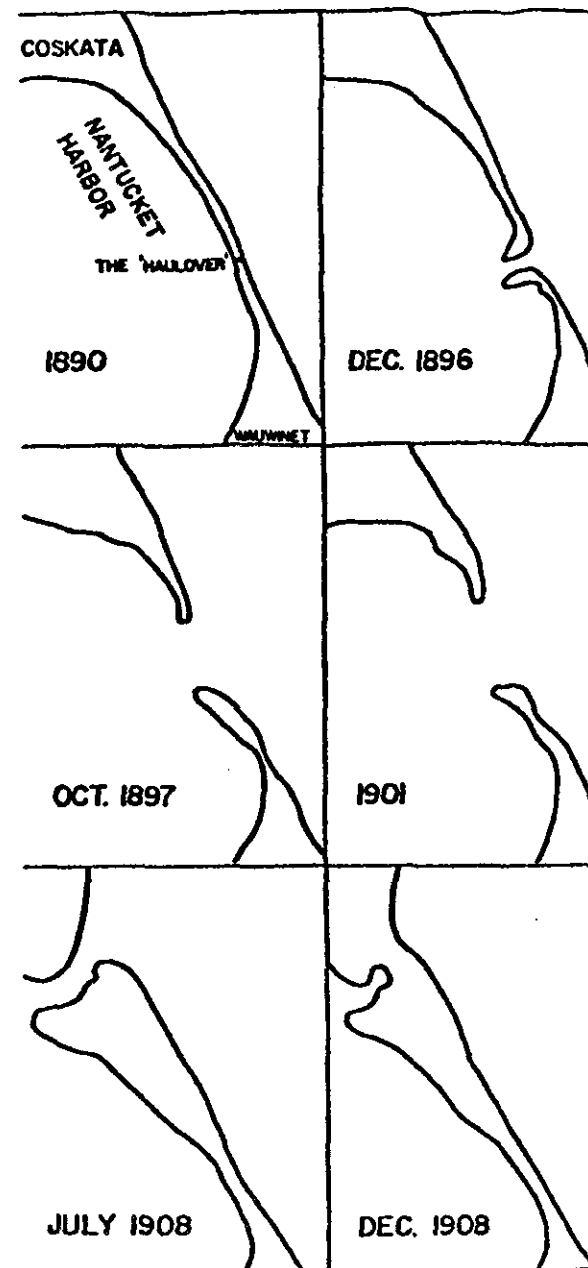
narrowest part of the beach to go cod-fishing on the shoals to the east of the island. Destruction of vegetation and the creation of a track through the dunes promoted by the fishermen's activities weakened the spit at the Haulover and led to the development of an overwash channel at this point. Under the influence of the prevailing northward longshore current, the channel migrated north over nearly a mile of beach until finally closing when it reached the Coskata upland in 1908. This cut, open for nearly 12 years, drastically altered the current patterns in Nantucket Harbor and promoted development of sandbars within the harbor (figure 14).

Figure 14. Schematic representation of changes at the haulover between 1890-1908. (From Rosen, 1972)

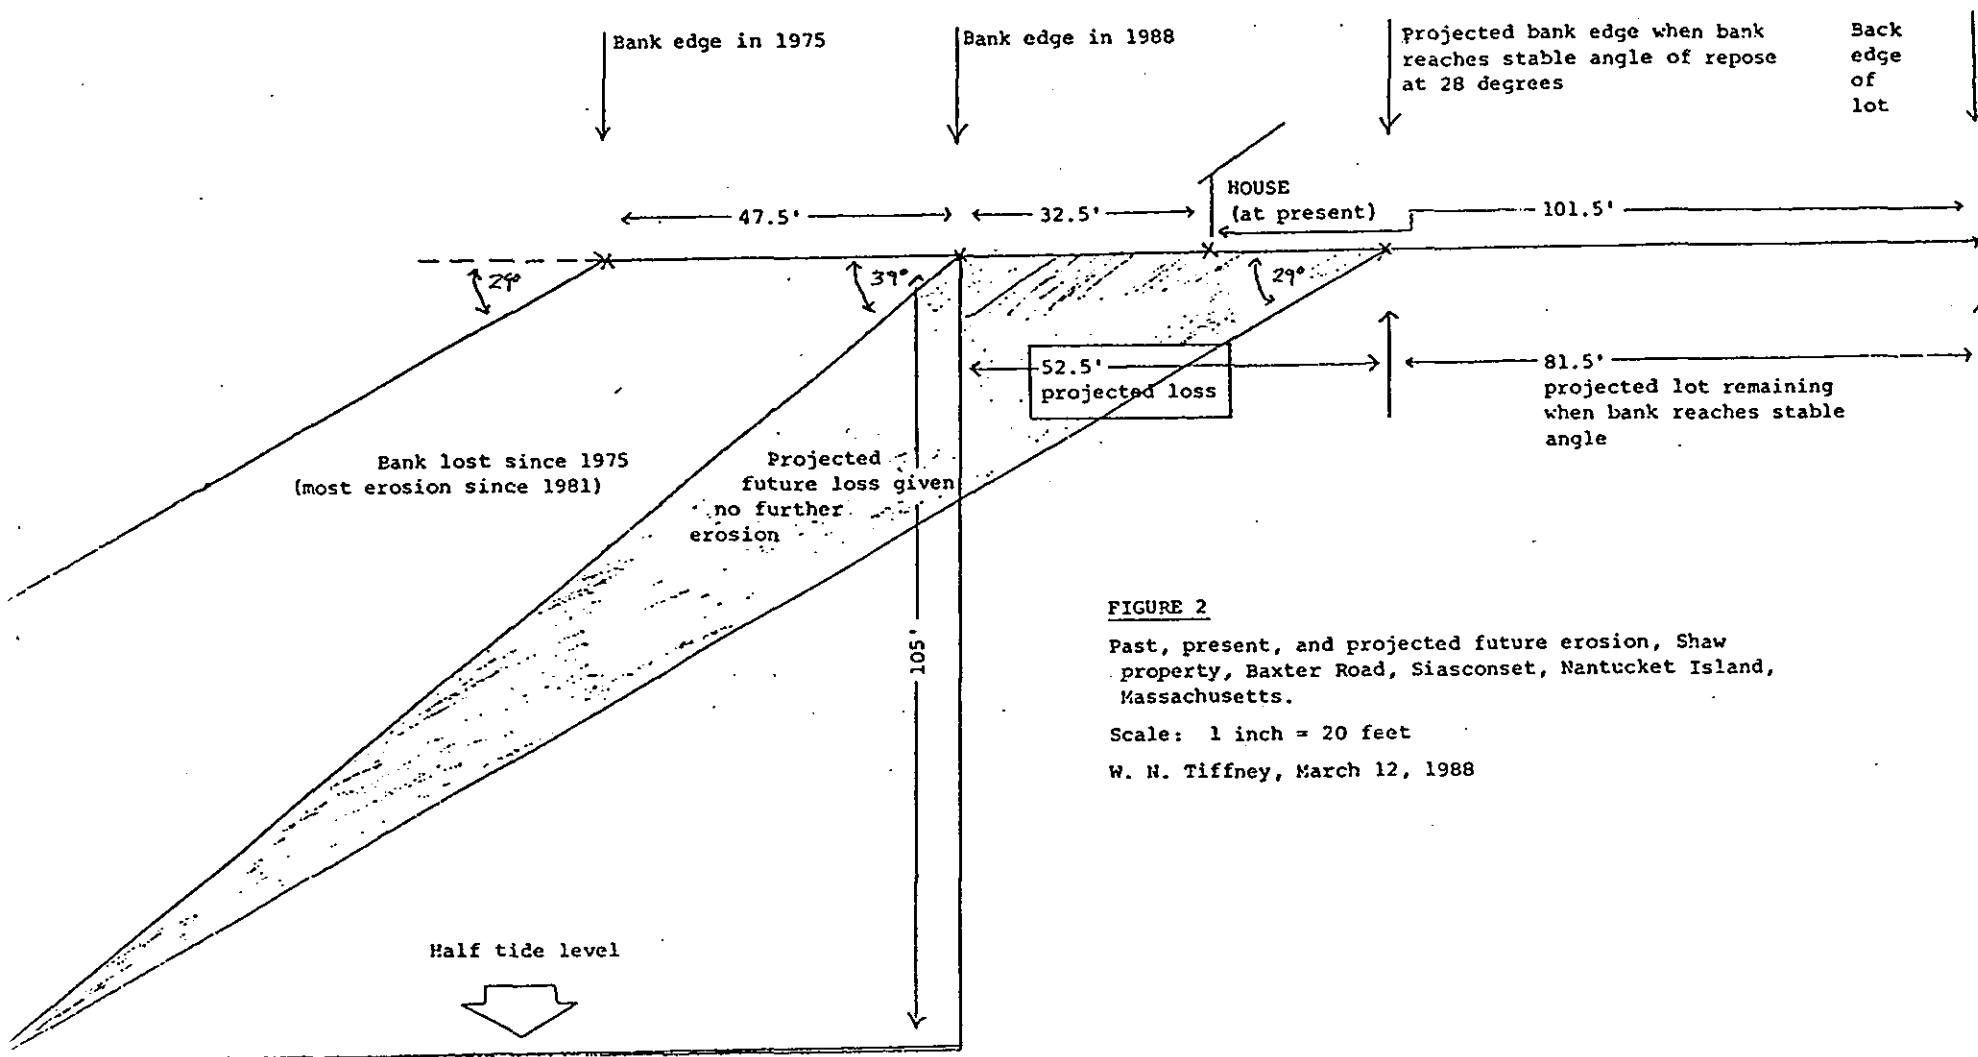
FIGURE 2

This means that even if erosion at the bank base ceased now, for the bank to achieve stability and become vegetated, it would need to slump until the bank angle decreased from 39 to 29 degrees. Resulting retreat of the bank lip to achieve the stable angle may be estimated from a scale drawing (Figure 2). In Figure 2, I have indicated the amount of bank lost since 1981 (47.5 lateral feet), the distance from the bank lip to the house on March 10, 1988 (32.5 feet), and the remaining distance from the front of the house to the back of the lot (101.5 feet). I have also indicated projected loss due to bank slump. This distance is 52.5 feet, leaving only 81.5 feet of the lot remaining in the rather unlikely event that stability is achieved.

Past, present, and projected future erosion, Shaw property, Baxter Road, Siasconset, Nantucket Island, Massachusetts.
